Manhole Inspection Summary

Manhole # S35QQ_012MH

Insp Date: **1/23/07 12:56 PM**

Location Address: **2412 BARCLAY ST**

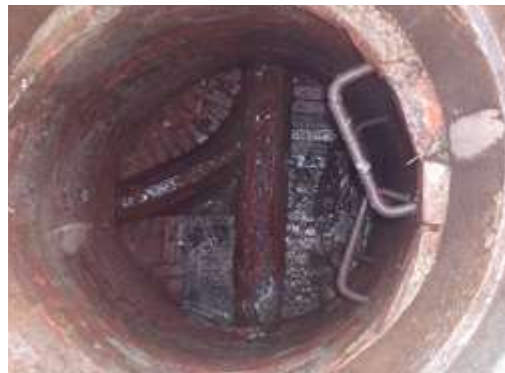
Top View

Bench debris.

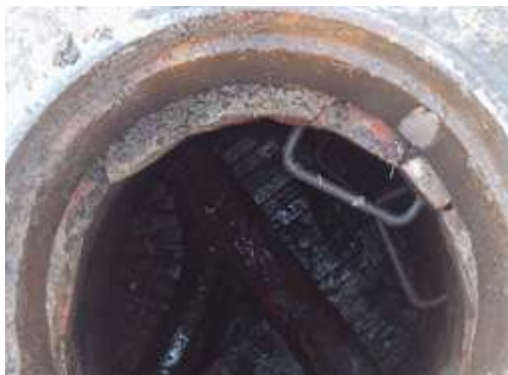
Defect

☒ **Leaks**

Condition: ☐ Sound ☐ Cracked ☐ Root Intrusion ☒ **Loose Brick** ☒ **Deteriorated**

Infiltration: ☐ None ☒ **Joint** ☐ Cracks ☐ Mortar ☐ Roots ☒ **Wall**

Frame leaks. Frame offset. Adjustment deterioration, loose brick and infiltration.

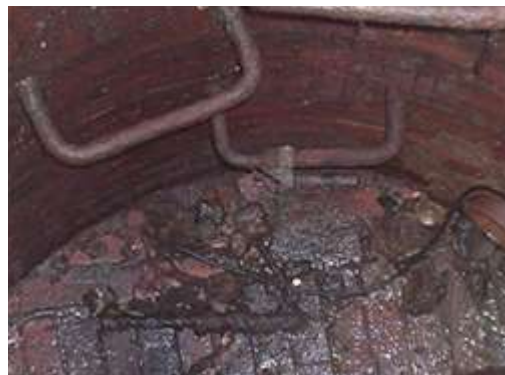
Defect

Steps Count: **4** Missing: **0** ☒ **Corroded**

Surcharge ☒ **Evidence Of Surcharge** Depth: **1** (ft.) ☐ Active Surcharge Present

Corroded steps. Evidence of surcharge - Bench debris.

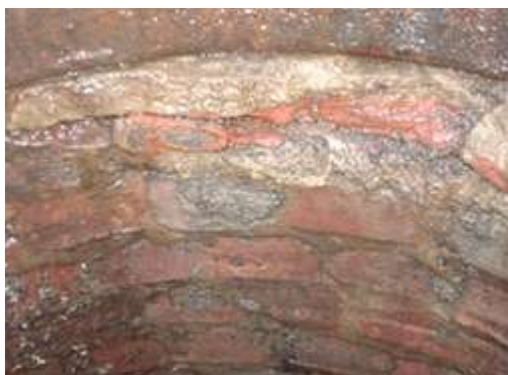
Defect

Frame leaks. Adjustment deterioration and infiltration.

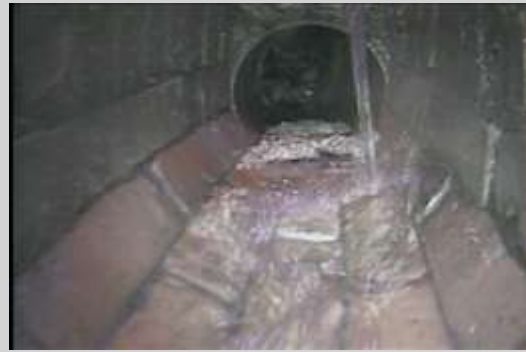
Drop In @ 6 O'Clock

Channel deterioration.

Drop Condition: **Clogged**

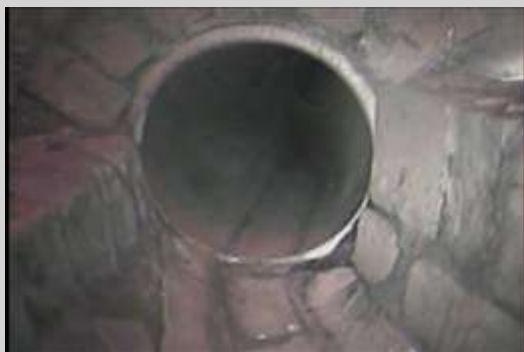
Pipe In @ 9 O'Clock

Pipe Seal Cond: **Roots**
